# Home Inspection Report

142 Birchwood Court, Columbus, OH 43215

**October 26, 2026**

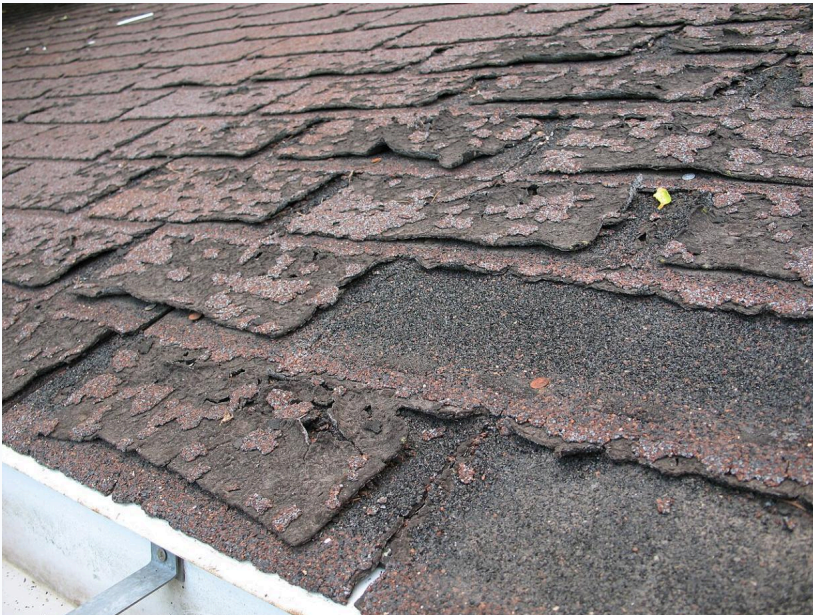
Photo 1: South slope, near ridge

Significant granule loss and curling shingle tabs across the south-facing slope, with several tabs cracked or missing near the ridge. Shingles in this condition no longer shed water reliably, and leaks into the roof deck and attic are likely.

### MAJOR South slope, near ridge

**Why it matters:** Shingles in this condition no longer shed water reliably, so leaks into the roof deck and attic are likely and the damage compounds each season.

*Recommendation: The covering is at or beyond its typical service life. Budget for full replacement and have a licensed roofer confirm the condition of the deck beneath.*

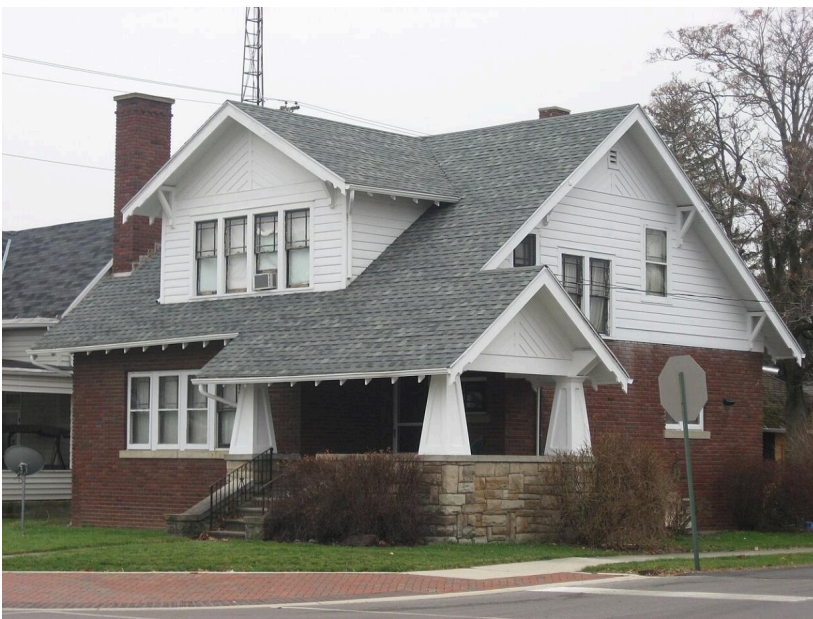
Photo 1: Siding and trim

**Exterior - Siding and trim:** Painted wood trim at the base of the rear wall is soft and checking where it sits close to grade. Moisture here can lead to rot if the paint film is not maintained. (page 7)

### MINOR Rear elevation, lower trim

Painted wood trim at the base of the rear wall is soft and checking where it sits close to grade. Moisture here can lead to rot if the paint film is not maintained.

**Why it matters:** Trim that stays wet rots, and rot can spread into the wall framing behind it.

*Recommendation: Scrape, prime and repaint the trim, replace any boards that are soft to a probe, and keep soil and mulch below the trim.*

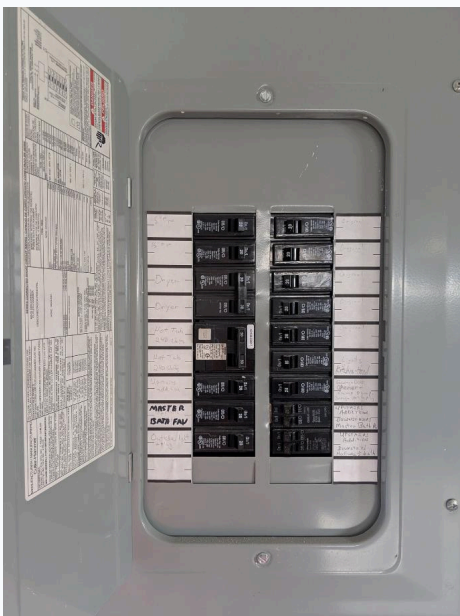
Photo 1: Main panel, basement utility room

Several breaker labels are illegible or missing, and two circuits share a single breaker not rated for that use (double-tapped). A loose or overloaded connection at a breaker can overheat.

### MAJOR Main panel, basement utility room

**Why it matters:** A loose or overloaded connection at a breaker can overheat and is a fire risk.

*Recommendation: Have a licensed electrician relabel the panel directory and correct the double-tapped breakers.*

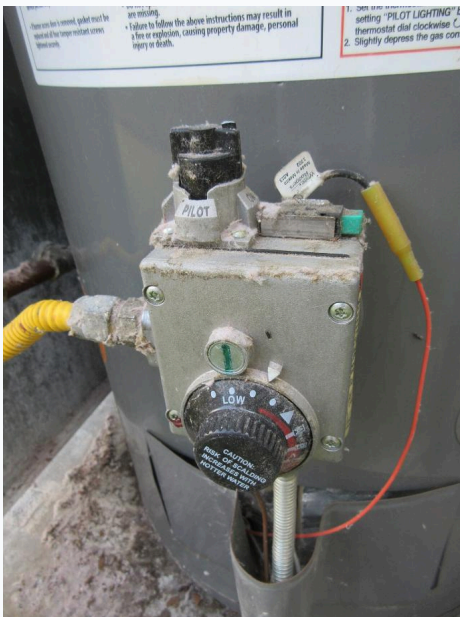
Photo 1: Utility room

**Plumbing - Water heater:** The tank is 11 years old, near the end of the 10 to 15 year life typical of this type of unit, and dust and sediment have built up around the gas control valve and pilot assembly. A failed tank can release a large volume of water. (page 11)

**MINOR** Utility room

The tank is 11 years old, near the end of the 10 to 15 year life typical of this type of unit, and dust and sediment have built up around the gas control valve and pilot assembly. A failed tank can release a large volume of water.

**Why it matters:** Tanks near the end of their life can fail suddenly and flood the area around them.

**Recommendation:** Have the unit serviced and the burner assembly cleaned, and plan to replace it within the next few years. Consider a drain pan piped to a floor drain.

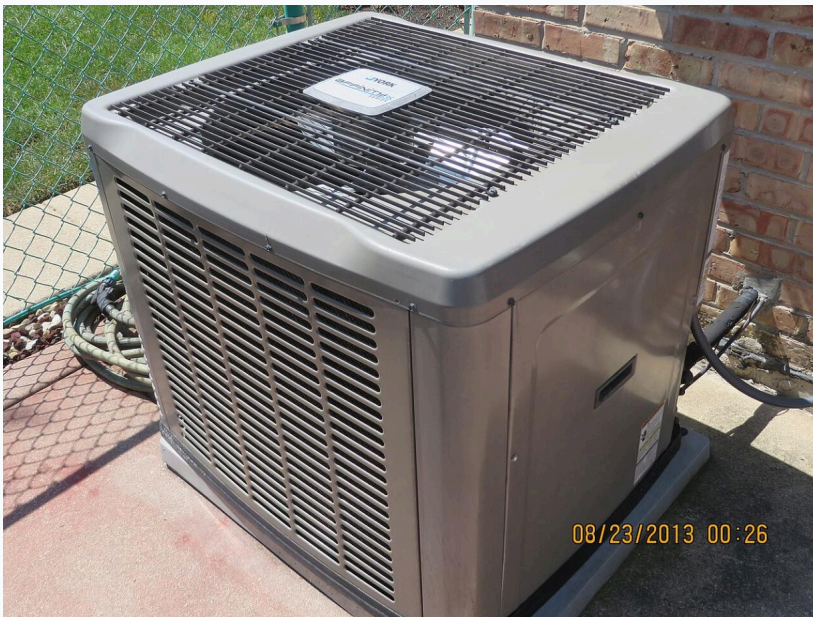
Photo 1: Rear yard, west side of house

**HVAC - Cooling system:** Leaves and grass clippings have collected around the base of the outdoor condenser and restrict airflow. (page 12)

**MAINTENANCE** Rear yard, west side of house

Leaves and grass clippings have collected around the base of the outdoor condenser and restrict airflow.

**Recommendation:** Clear debris from around the unit each spring to maintain proper airflow.

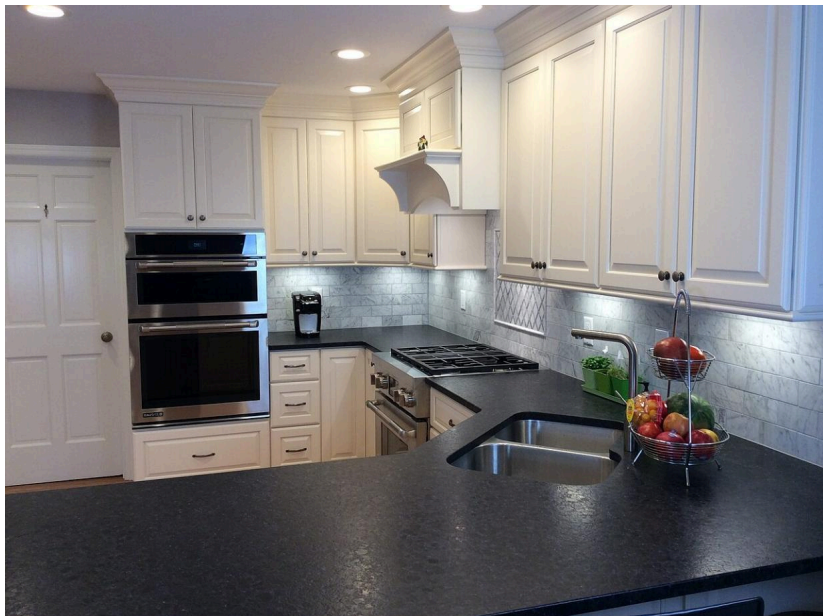
Photo 1: Kitchen

**Interior - Kitchen:** No anti-tip bracket could be seen at the freestanding range. A range can tip forward if a child climbs on an open door. (page 14)

*Recommendation: Confirm that an anti-tip bracket is installed, and install one if not.*

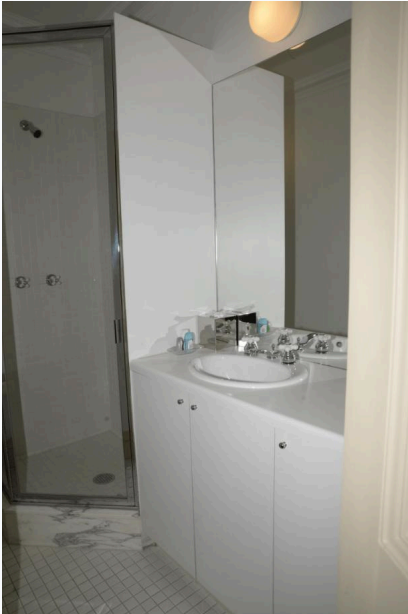
Photo 1: Primary bathroom shower

**Interior - Bathrooms:** Caulking at the shower enclosure is cracked and separating in several spots. Water that gets behind it can damage the wall. (page 15)

Caulking at the shower enclosure is cracked and separating in several spots. Water that gets behind it can damage the wall.

**Why it matters:** Failed caulking lets water behind the tile, where it can rot the wall behind.

**Recommendation:** Remove and replace the caulking to maintain a proper water seal.
